### Borg Beck Clutch Installation

### Important Installation Notice

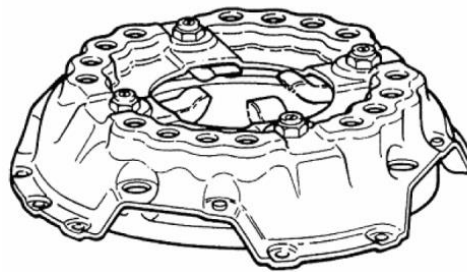
The primary cause of lever strut displacement has been identified as the release lever or release lever plates being pulled away from the flywheel, putting excess pressure on the anti-rattle spring. This results in the strut being left in a "free" position and will cause it to fall out of the correct pivot position. One or more release levers positioned higher than the other would indicate a strut being out of position. If this problem is not corrected, the clutch will not function properly. Please call our Service Department if you identify this issue
