W331569 [9" Single Stage Pressure Plate - Reman]

Instruction Guide

Borg Beck Clutch Installation

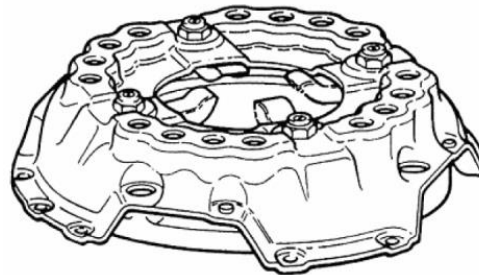
The primary cause of lever strut displacement has been identified as the release lever or release lever plates being pulled away from the flywheel, putting excess pressure on the anti-rattle spring. This results in the strut being left in a "free" position and will cause it to fall out of the correct pivot position. One or more release levers positioned higher than the other would indicate a strut being out of position. If this problem is not corrected, the clutch will not function properly. Please call our Service Department if you identify this issue (1-800-247-1824)

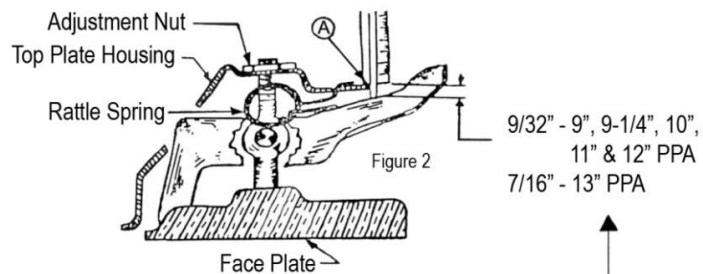
Distance from top of housing (top plate) to top of finger should measure
See figure 2 (A).

9/32" - 9", 9-1/4", 10",
11" & 12" PPA
7/16" - 13" PPA

1. Check adjustment as outlines below
2. **Stake adjustment nuts on each side of eye bolt**

Clockwise adjustment closes the distance.
Counterclockwise adjustment increases gap distance (applies also to four finger clutches).
