### Borg Beck Clutch Information

### Spacer Kit for Ford/New Holland Tractors

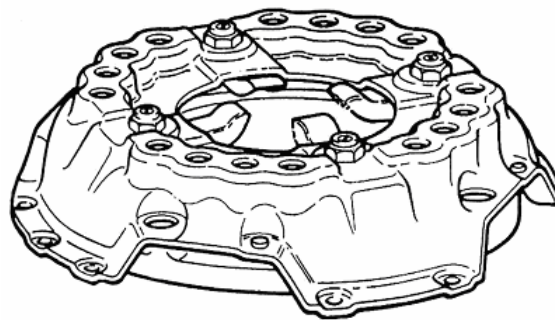
The primary cause of lever strut displacement has been identified as the release lever or release lever plates being pulled away from the flywheel, putting excess pressure on the anti-rattle spring. This results in the strut being left in a "free" position and will cause it to fall out of the correct pivot position. One or more release levers positioned higher than the other would indicate a strut being out of position. If this problem is not corrected, the clutch will not function properly. Please call our Service Department if you identify this issue.
