W870880N [11" Single Stage Pressure Plate - New]

Instruction Guide

Borg Beck Clutch Installation

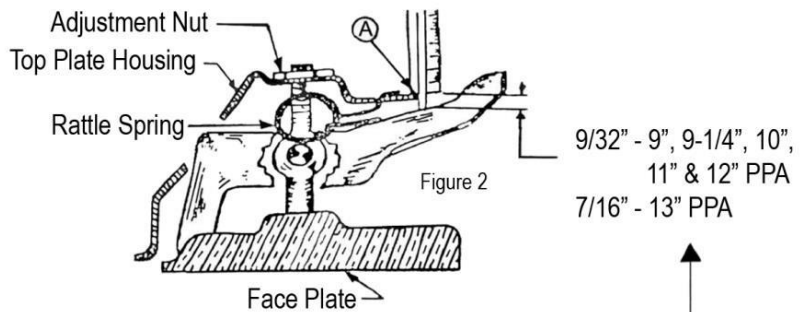
Clockwise adjustment closes the distance.
Counterclockwise adjustment increases gap distance (applies also to four finger clutches).

9/32" - 9", 9-1/4", 10",
11" & 12" PPA
7/16" - 13" PPA

Distance from top of housing (top plate) to top of finger should measure _____
See figure 2 (A).

1. Check adjustment as outlined below
2. **Stake adjustment nuts on each side of eye bolt**
