W168823 [12" Single Stage Pressure Plate - Reman]

Instruction Guide

Borg Beck Clutch Installation

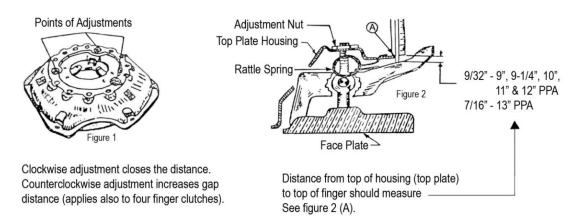
- 1. 6 spacers are included with W168823 and 8 spacers with W168011 for use with flywheels that do not have a .125" step. If your flywheel does not have a .125" step, install these spacers between flywheel and pressure plate mounting surface. If your flywheel does have the .125" step, do not use the spacers
- 2. Check adjustment as outlines below
- 3. **IMPROTANT**: Stake adjustment nuts on each side of eye bolt

The primary cause of lever strut displacement has been identified as the release lever or release lever plates being pulled away from the flywheel, putting excess pressure on the antirattle spring. This results in the strut being left in a "free" position and will cause it to fall out of the correct pivot position. One or more release levers positioned higher than the other would indicate a strut being out of position. If this problem is not corrected, the clutch will not function properly. Please call our Service Department if you identify this issue (1-800-247-1824)
